# Plaster Protecting Himeji Castle, World Cultural Heritage and National Treasure

**Mr. Kozo Ueda**

*Himeji City Office / Japan*

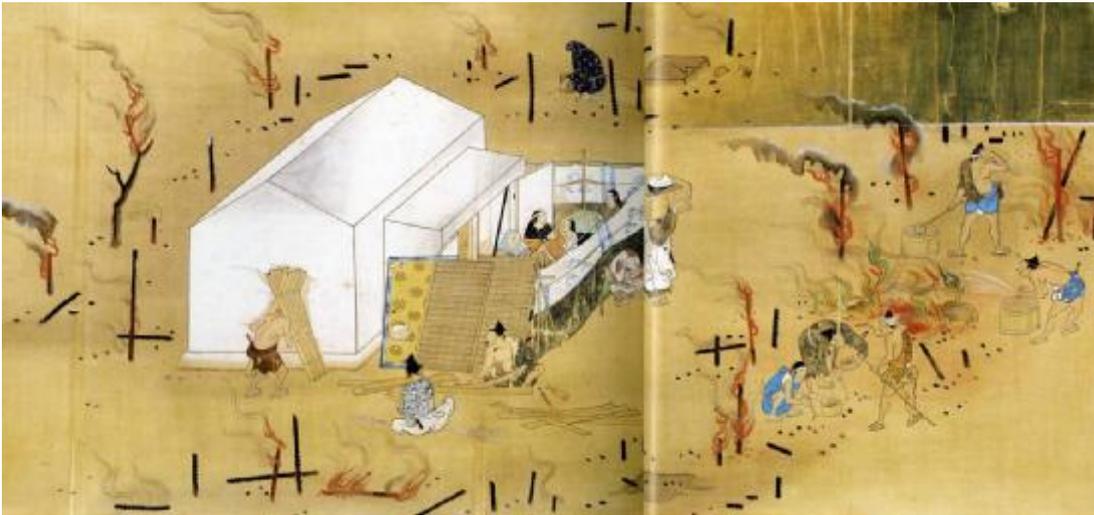
This painting depicts a great fire in Kyoto in 1309, during the Kamakura period. You can see people taking shelter in a warehouse with whitewashed walls. Plaster-finished walls were highly resistant to fire. Such a building was also highly resistant to natural elements and elastic deformation.

*Great fire in Kyoto, 1309 (Kamakura period), dedicated to Kasuga Shrine (source: “Kasuga Gongen Kenki-e, the Miracles of the Kasuga Deity” published by Chuokoronsha, Inc. in 1991)*

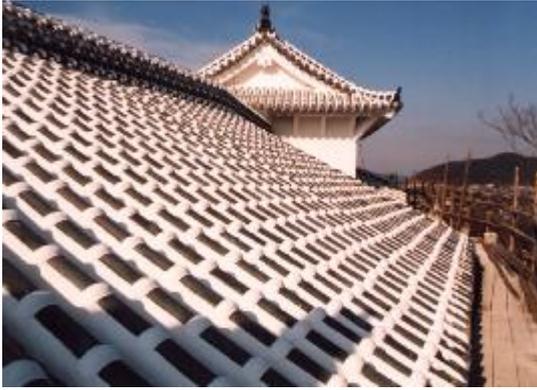
**Himeji Castle's passage turret**

These photos show **plastering on the roofs of Himeji, Kumamoto and Matsuyama Castles**. In the case of Matsuyama Castle, on large roofs plastering is applied only along the edges.

Almost all of the castle’s **exterior walls** and **eave supports** are completely finished with plaster. The **inner walls** of the rooms are finished either with plaster or earth, depending on their purpose of use. Plastering is also found on the castle’s roofs, in **roofing joints**. Plastering in roofing joints is very rare among Japanese castles. From my recent studies, I have concluded that the roofing joints were probably not plastered at the time of Himeji Castle’s construction.

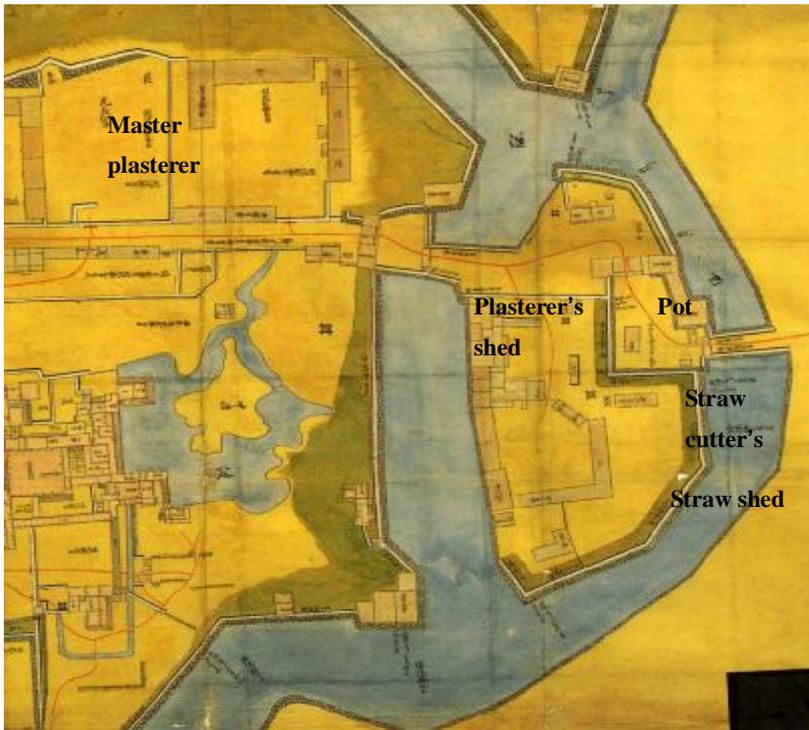
This grand painting of Himeji Castle from the Edo period, around 1700, shows locations where plasterers worked in those days. There are inscriptions such as "master plasterer," "plasterer's shed," "straw cutter's shed" and "straw shed." This indicates that plasterers were permanently stationed on the castle grounds for frequent repairs of the walls and other daily tasks.

*Grand Painting of Himeji Castle* (Source: "Banshu Himejijo-zu, grand painting of Himeji Castle" in the possession of Mr. NAKANE Tadayuki)

- Until around 1920, Himeji Castle was protected against the elements by an extremely thin layer of plaster applied to thick earthen walls.
- During the Edo period (1610 – 1868), plasterers were permanently stationed on the castle grounds for daily wall repair.

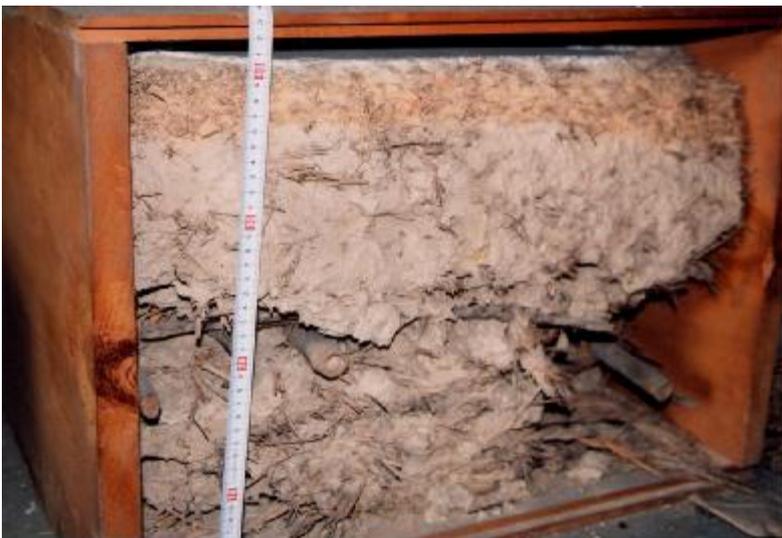
Western wall on the first floor of the Watari Yagura (passage turret)

I estimate that the plaster in this photo was applied at the time of the **castle's major renovation in 1910**. The remaining documents indicate that the external wall was finished with a thin coat of about 3mm of white plaster made of oyster ash, lime, brown algae, nut oil and cut pieces of straw.

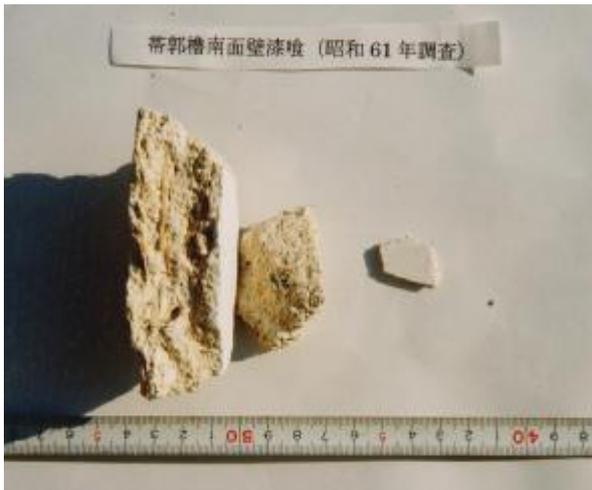
As a result, **two plastering techniques** are used for Himeji Castle. The photo at left shows a portion of the Obikuruwa turret external wall, on which the castle's special technique was applied (plaster containing cut pieces of straw). The photo at right shows a wall on which the conventional technique was used.

Plaster containing cut pieces of straw on external wall of Obikuruwa turret (about 33 mm thick)

**Himeji Castle's "special" plastering technique** was also developed as a result of research into plastering intended for the external walls of the main donjon. In the **"special" plastering technique**, the undercoat is 30 mm thick and contains cut pieces of straw, while the final coat is a 3-mm layer of plaster, as in the Edo period plastering technique. In total, a 33-mm layer of plaster is the result.

This technique is still used to repair the structures that were first renovated between 1950 and 1955, namely, two turrets and four earthen external walls. This is the only Japanese plastering technique that involves the use of cut straws as-is, with algae for kneading paste.

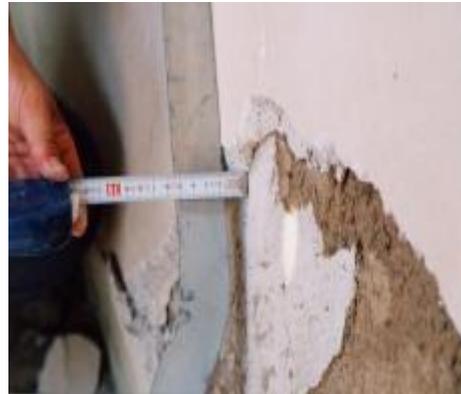
Wall of passage turret (about 13 mm thick)

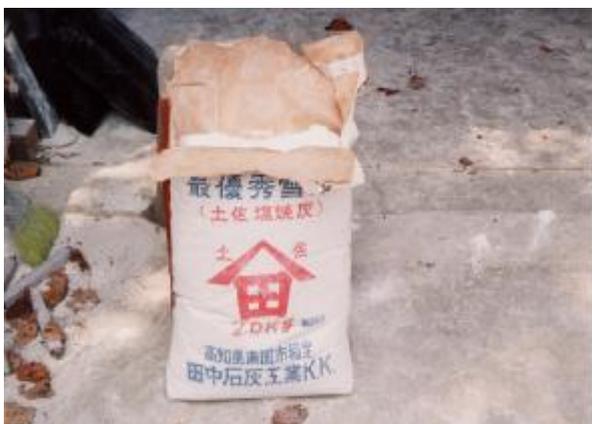
As for **techniques and ingredients used today**, the plastering techniques are mainly based on the improvements realized during renovation of the main donjon. The ingredients, on the other hand, come from locales quite different from the past. For example, the photo at left shows salt-sintered slaked lime from Kochi Prefecture. The photo at right is shell ash of ark shells from Kumamoto Prefecture.

Salt-sintered slaked lime from Kochi Prefecture

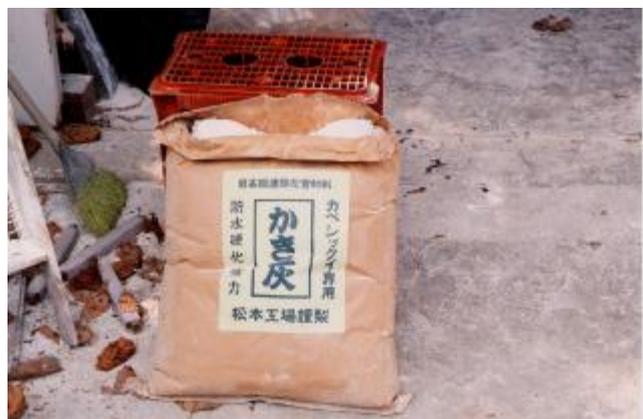
Shell ash of ark shells from Kumamoto Prefecture

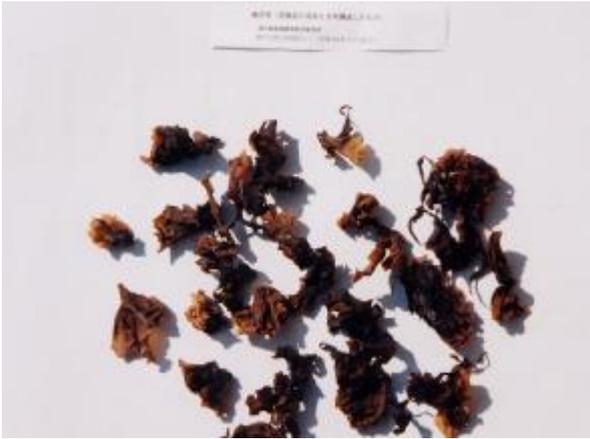
This is **algae paste**, made of red alga grown in Hokkaido; it is boiled in a pot like this.

**Red alga grown in Hokkaido**  
(left to sit for 2 years)

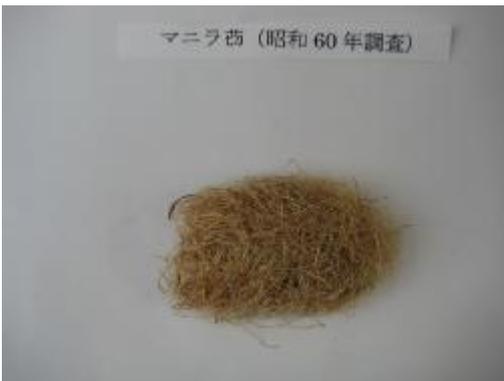
**Manila straw**

These are different types of **cut pieces of the plant fiber** that is added to prevent cracking. The fibers are used for undercoating or final coating, depending on the degree of bleaching.

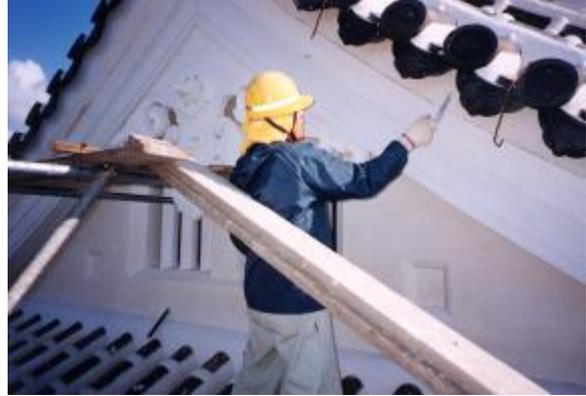
**Plastering on a gable**

These photos show workers **kneading and applying plaster**.
