# **A STUDY ON RESIDENTS' STRATEGY FOR HOUSING RECONSTRUCTION AFTER THE 2006 CENTRAL JAVA EARTHQUAKE**

**Abstract:** The damage of the 2006 Central Java Earthquake was concentrated on housing and private sector buildings. The Indonesian Government launched a financial aid measure for housing reconstruction. The residents have been very flexibly elaborating strategies in order to use the insufficient financial aid as effectively as possible for housing reconstruction. For example, 1) they are skillfully using a combination of temporary shelters and permanent rebuilt houses to maximize the limited space; 2) they both use the mutual corporation (*gotong-royong*) and hire carpenters to effectively use the limited funds; 3) they have separated a household into two or more households so as to obtain more funds. Their strategies were seen through interviews with the residents during our field study, which is illustrated in this report.

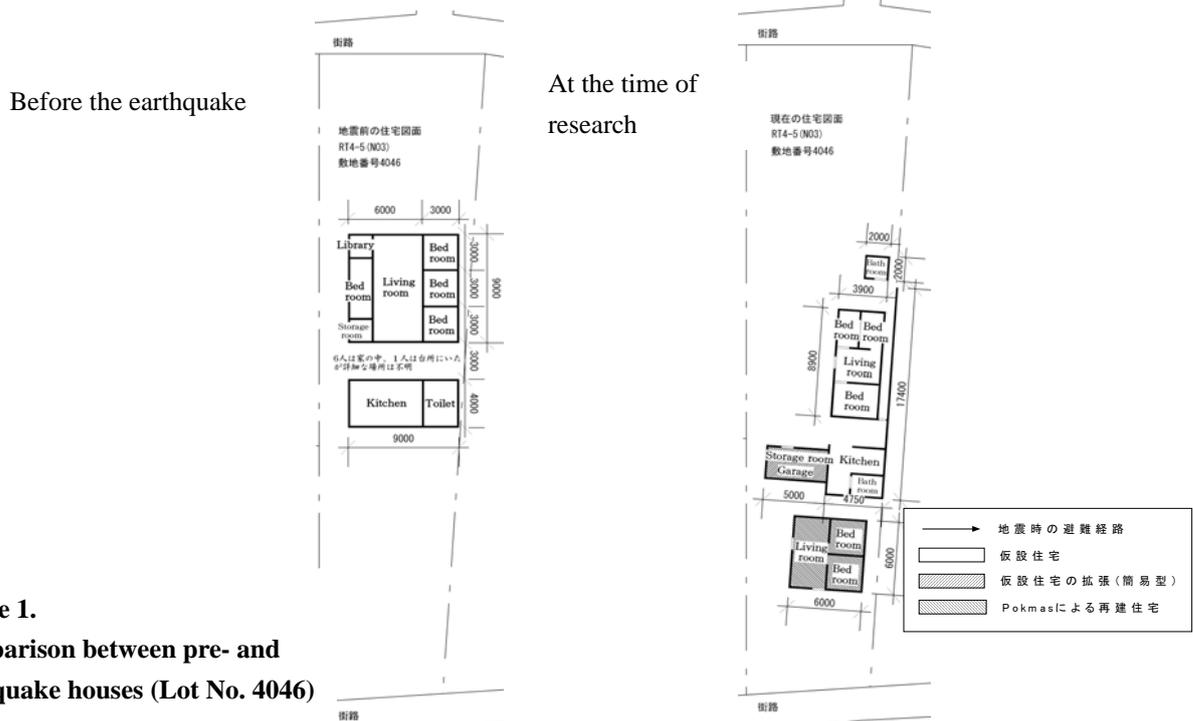
**Figure 1.**  
**Comparison between pre- and post-quake houses (Lot No. 4046)**

The household shown in Figure 1 consists of 7 family members. The house reconstructed through the Pokmas system is built in a space which can be separated for the son's household in the future (the location which used to be a backyard before the earthquake and has access to the road on the opposite side). The head of the household, a 62-year-old male, intended to live on in the temporary house (built in a place where a house used to be before the earthquake) in the future because he had no financial prospects. The only thing which appeared to matter is that the temporary house was occupying the space toward the front yard, where a permanent house should be built.

We made drawings of houses before and after the earthquake from the results obtained through the interviews with the 13 surveyed households. A comparison shows that the functions which were performed in a single house before the earthquake are now carried out both in the temporary house and the permanent house. That was the situation at the time of the research, one and a half years after the earthquake, and at that point, both the temporary house and the permanent house were in use in parallel. The layout of pre-quake houses made from the interview research and the layout of current houses obtained by actual measurement are shown as Figure 1 and Figure 2.

- ① The parallel use of a rebuilt house and a temporary house increased the building coverage, resulting in the decrease of common space, such as a front yard.
- ② In many cases, people reconstructed houses by separating their household into a parents' household and children's households. As a result, as in ①, the building coverage increased and the space for evacuation decreased.

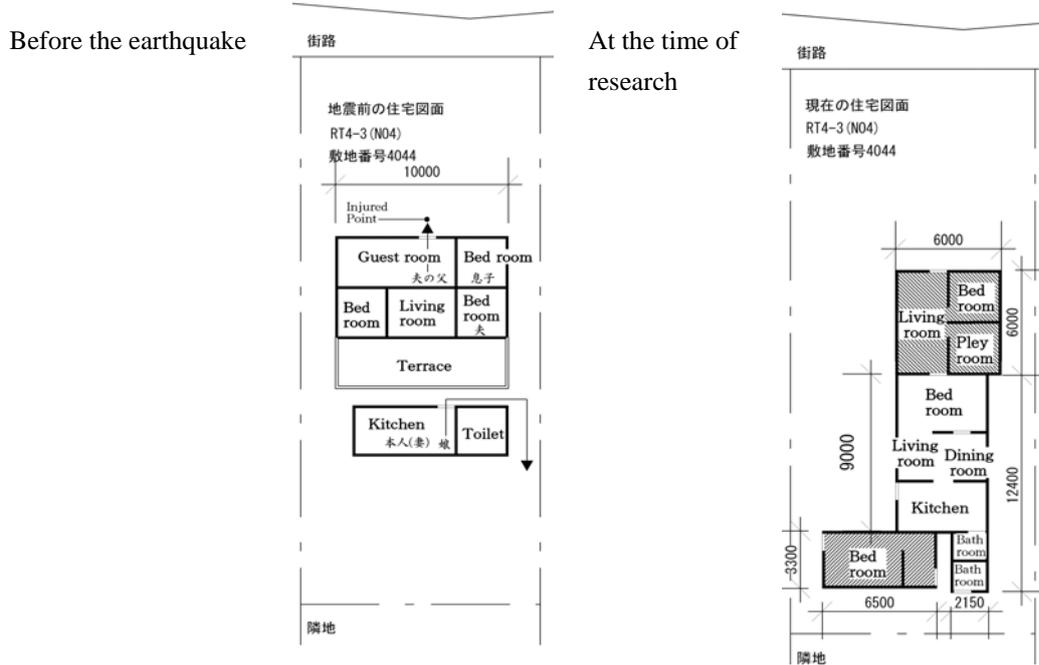
Figure 2. Comparison between pre- and post-quake houses (Lot No. 4044)

In the case of the household in Figure 2, the residents built a temporary house at the back of the site, then reconstructed a house through the Pokmas system in the front part, where their house used to be before the earthquake. As described below, this is the typical pattern of reconstructed houses built through the Pokmas system.

In general, they have bedrooms and living rooms, where they spend long periods of time in the reconstructed houses, while using temporary houses as kitchens and toilets, where they spend short periods of time.

We compared the layout of houses as they were before and after the earthquake. The room layout before the disaster was on the order of: road (indicated by a solid line in the drawings) → front garden functioning as a common space → guest room → living room/bedroom → kitchen/toilet → property line.

The current layout is, on the other hand, on the order of: road → front garden functioning as a common space → reconstructed house (living room/bedroom) → temporary house (kitchen/toilet) → property line. In the case of constructing the second house due to, for instance, the division of a household, it continues in the back with a “reconstructed house (in the case a second one is built) → road on the opposite side.” This result indicates that there was not much change in the basic layout of the housing function. We examine the reason for the current layout of a house from two viewpoints: the transition of housing after the earthquake and the order of construction.

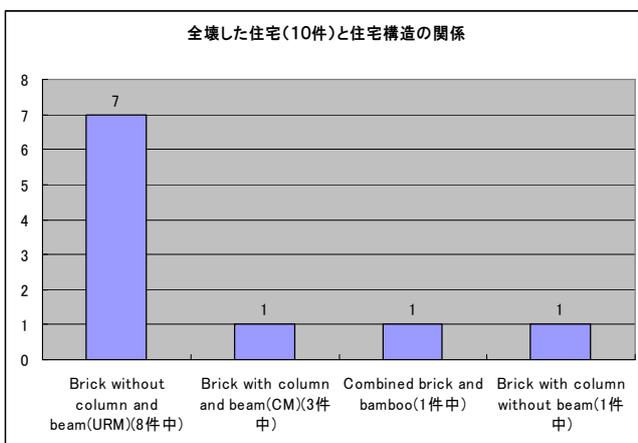
**Figure 3. Structure of Collapsed Houses**

Ten houses collapsed totally and, among those, 7 did not have columns or beams. There were actually 8 houses without columns and beams. The one that did not collapse had been reinforced by thickening the bricks. In one case of a house that had columns and beams but still collapsed, the house was already 46 years old, and it is possible that the locations of the columns and beams were not quite adequate, since the house had not been constructed by carpenters. The characteristics of the houses that did not collapse can be summarized as below:

- (A) Built with bricks, and had columns and beams
- (B) A professional carpenter was involved in the construction.
- (C) Comparatively new

Regarding housing damage, 13 cases of interviews in Plenbutan Sub-Village showed that 77% of the houses (10 of 13 houses) collapsed completely during the earthquake. The houses that did not completely collapse have some certain characteristics.

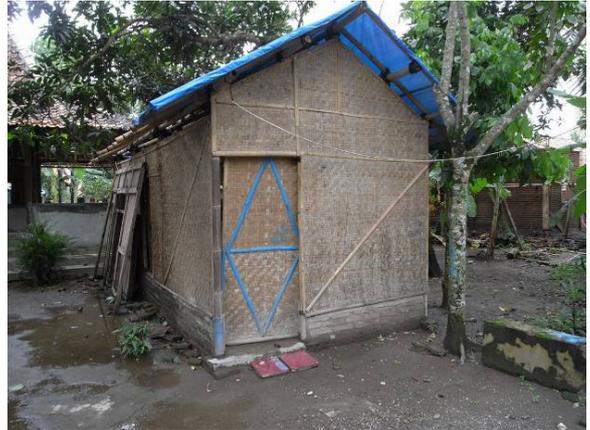
**Photo 2. Case of temporary house still in use after a permanent house was built**

At the time of this research (November 2007), when one and a half years had passed, there were many cases in which a reconstructed house and a temporary house were both used. It is assumed that people first built a permanent building

for bedrooms and a living room, where they spend long periods of time, while using the temporary building for the kitchen and toilet, where they spend only short periods of time, and that the temporary section would be rebuilt in the future. This assumption is backed up by the fact that some respondents answered that they did not intend to continuously use the temporary house in the future but rather wanted to rebuild it when they could afford it. The temporary building section is utilized in a flexible way depending on the financial situation of the individuals: If the kitchen or toilet collapsed, there would not be much actual harm; they are using anything they can use. Here can be seen their housing norms, in which removal of the temporary houses is not pushed needlessly in order to force the reconstruction process to move forward, and the people's down-to-earth way of living is respected. This is regarded as one of the reasons that the reconstruction process did not appear to have been too severe in the sub-village as a whole.
